Home Inspection Report

1234 Samplereport Avenue - Boise, Idaho

January 1, 2005

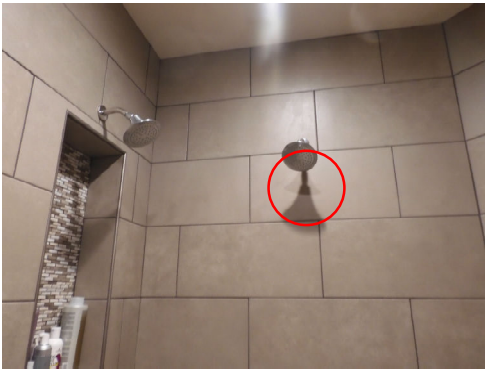
Image 1

One of the two Master Shower heads is a bit loose at the piping from the shower wall (No leakage was detected, however.)

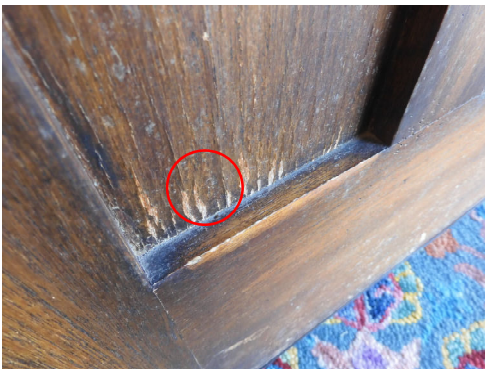
Image 2

The wooden front entry door is due for refinishing of the exterior side.

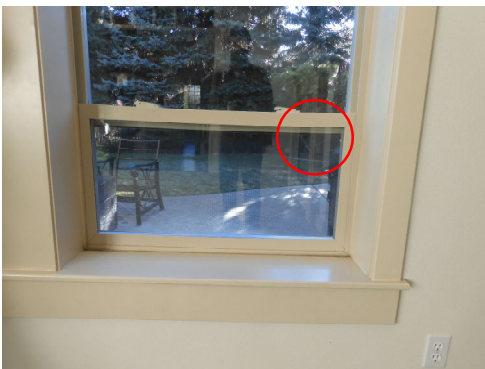
Image 3

The two 'single-hung' windows along the rear of the Great Room have some distortion of the plastic frame(s). This is causing the windows to not close freely, and for a small gap to be present at the lower corners of both of the windows.

Recommend further evaluation by a window company for possible replacement of the affected sections.

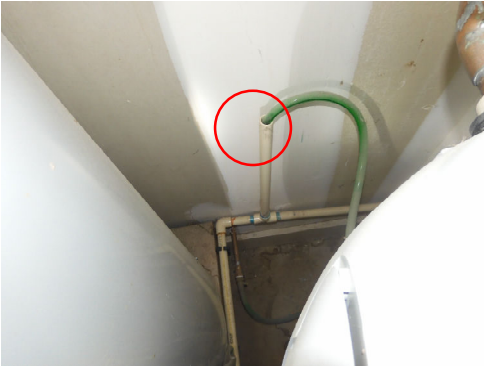
Image 4

A non-standard 'tie-in' to the PVC discharge pipe for the T&P valve of the water heater was noted. The tie-in is for the water softener.

This can be easily corrected by adding a dedicated PVC pipe instead, and routing it parallel to the existing one.

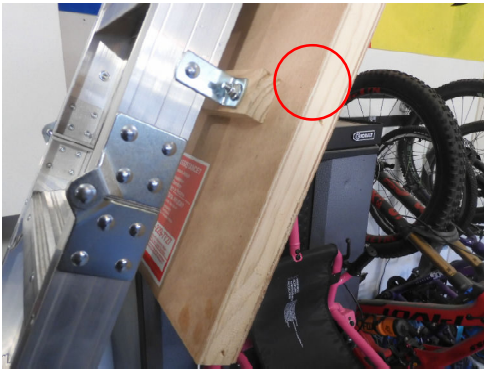
Image 5

Ceiling **Appears serviceable** Stains Damage Ladder does not appear to be fire rated (4)

Although the attic 'pull-down' ladder appears to be one of the best available, it is not known if it is 'fire-rated' for installation in the garage ceiling, which is a 'fire-barrier'.

Note: This is a Fire Safety item.

Recommend asking the seller if they have any manufacturer document that relates to the it being rated for such.

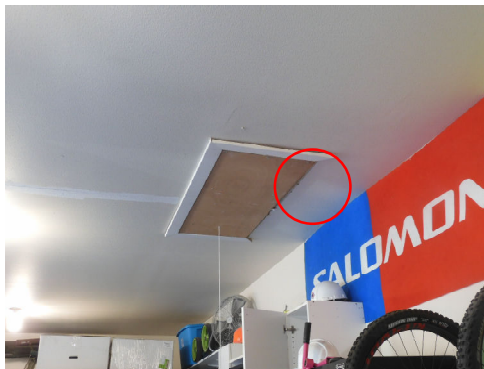
Image 6

Continued from above... there is missing trim, and a small gap along the garage ceiling, at the juncture to the pull-down ladder.

For fire safety, correction is needed.

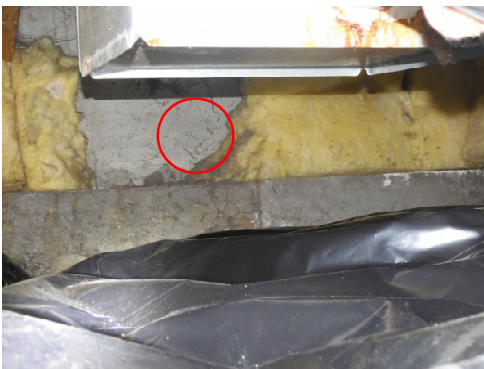
Image 7

A few locations of insulation are missing or pulled-away along the stem-wall of the home, as viewed from the crawl space (below home).

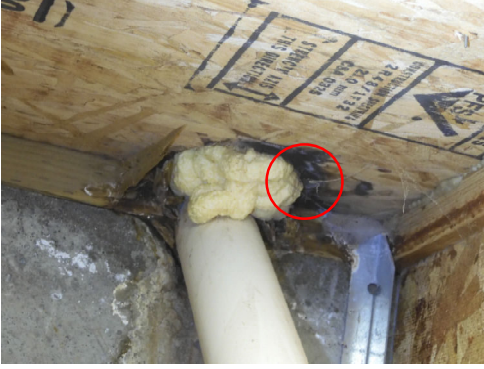
Image 8

Moisture Stains / Damage (2) (3) See note in summary pages at end of report. Earth to wood contact (2) (3)

Moisture staining and possible fungal growth was noted along the subfloor - located below the Master Bathroom sinks / cabinet area. This staining is near a drain pipe section, but it does not appear to be piping from the Master Bathroom, instead, it is likely a pipe from the upstairs bathroom. The leakage MAY not be related to the pipe, however. It is possibly moisture from the exterior, along the sill plate, at top of the concrete stem-wall. Further evaluation will be needed by a plumber or general contractor to isolate the source of moisture. Also, it is recommended that the area of staining be treated for possible fungus.

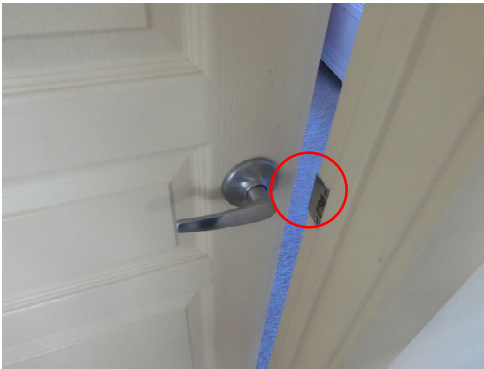
Image 9

The door latch to the upstairs 1st bedroom is in need of adjustment.

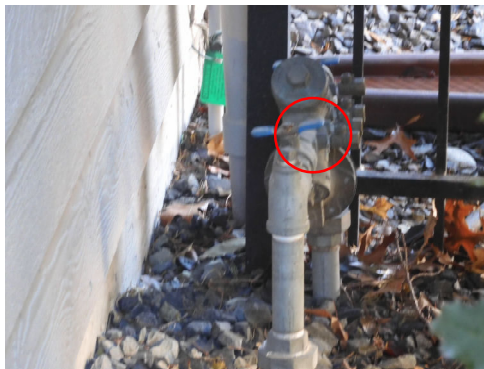
Image 10

SPRINKLERS Not Inspected - None / Winterized / Irrigation Water Automatic timers not tested
 Appear serviceable Control box location: Garage wall.
 Sprinkler heads too close to building Adjust spray away from structures / fences
 Comments: Seasonal limitation... No inspection. Note: The backflow valve is missing the test-tag for annual inspection.

I noticed that there is no 'test-tag' present on the irrigation Backflow Preventer Valve (Annual test is required by State.)
